CASE STUDY

Problem:

Shock and back pressure sends 2 1/2" check ball into 2" hole causing weekly pump repair.

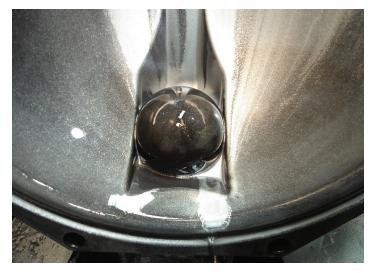
We were receiving pumps weekly that would have the check ball lodged into the fluid cap of the pump. This was a very strange site to see as the check ball is 2½" in dia. and the hole in which it was forced through was only 2" in dia. The balls were a Nitrile rubber and not easily deformable.

To remove the balls from the fluid caps of the pump we had to drill them out. The balls could not be driven out with a punch and hammer and the use of a hydraulic press risked deformation of the fluid cap itself.

There were no signs of chemical attack or deformation due to temp, so we recommended the use of a Blacoh dampener to absorb the shock from the system that we suspected was forcing the balls into the diaphragm chamber.

After installation of the dampener, which has been nearly 6 months to date, the pump has not been touched. Repairs and downtime from pump change outs have been eliminated on this line and the customer is looking to install the dampeners in other locations to save wear and tear on the pumps and piping system.
