CASE STUDY

Problem:

Shock and back pressure sends 2 1/2" check ball into 2" hole causing weekly pump repair.

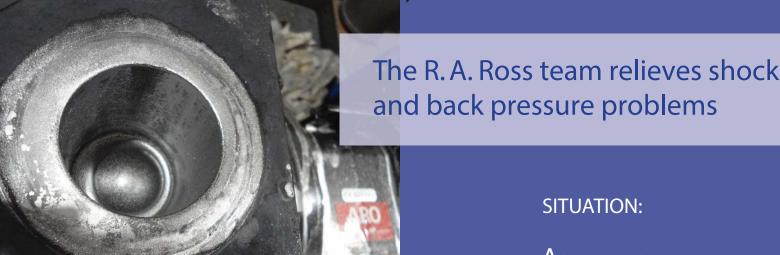
Air operated Diaphragm pump ball check was deformed and pushed through seat into fluid cap causing pump failure.

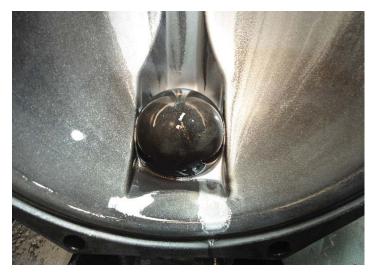
We were receiving pumps weekly that would have the check ball lodged into the fluid cap of the pump. This was a very strange sight to see as the check ball is 2½" in dia. and the hole in which it was forced through was only 2" in dia. The balls were a Nitrile rubber and not easily deformable.

There were no signs of chemical attack or deformation due to temperature. R. A. Ross recommended the use of a Blacoh pulsation dampener to absorb the shock from the system that we suspected was forcing the balls into the diaphragm chamber.

View of fluid end cap (Rotated 180°) where ball was pushed through seat into end cap.

After the installation of the dampener, which has been nearly 6 months to date, the pump has not been touched. Repairs and downtime from pump change outs have been eliminated on this line and the customer is looking to install the dampeners in other locations to save wear and tear on the pumps and piping system.

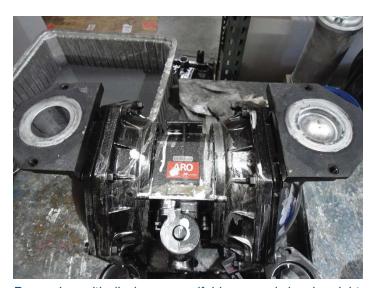
Pump view with discharge manifold removed showing right ball check pushed through seat into fluid end cap.
