CASE STUDY

TOUGH REPAIR

The R. A. Ross team's experience and innovative skills discover the problem behind the problem

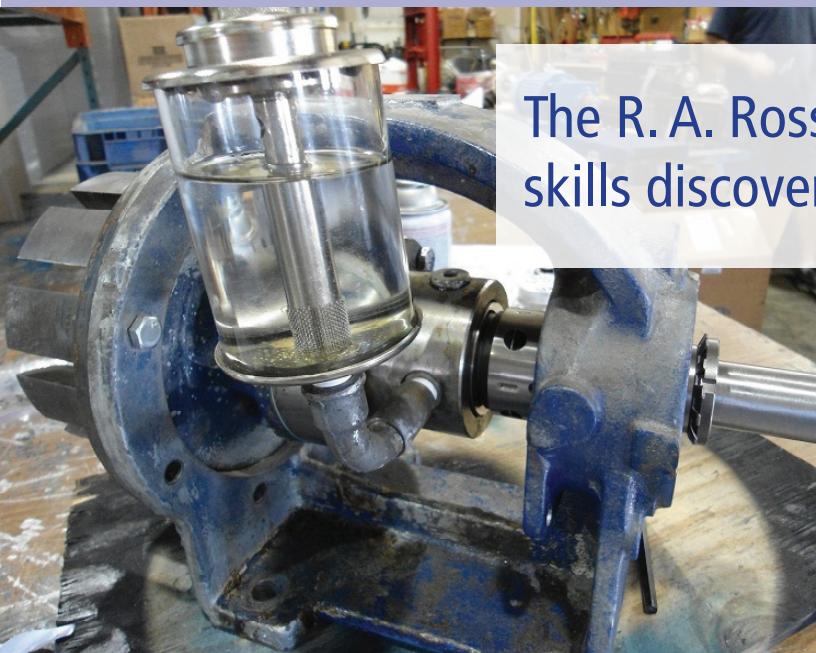
German made Italian owned company pump (pictured above) with no parts available in the US made obtaining parts very difficult and time consuming.

The pump was an ITP brand rotary gear pump model V60-2. The problem with the pump was that the mechanical seal was leaking. Upon inspection of the seal it was determined that the tungsten carbide rotary and the ceramic stationary were still in usable shape, but the holder for the tungsten insert was damaged.

To save the customer time and money we repaired the rotary holder, re-lapping the seal faces and installed new o-rings. With the mechanical seal back in working condition we found the real obstacle in repairing the pump was something that was not what it seemed.
